AFWAL-TR-84-4186

FRACTOGRAPHY OF MIXED MODE I - II FAILURE IN GRAPHITE/EPOXY
AND GRAPHITE/THERMOPLASTIC UNIDIRECTIONAL COMPOSITES

Steven L. Donaldson

June 1985

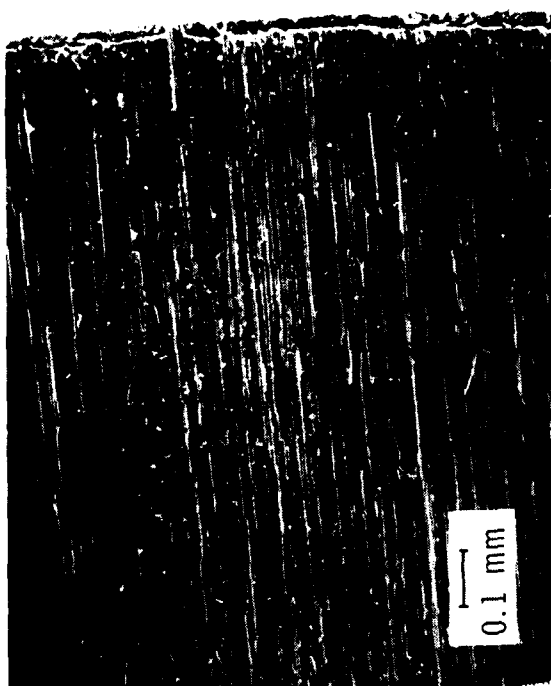
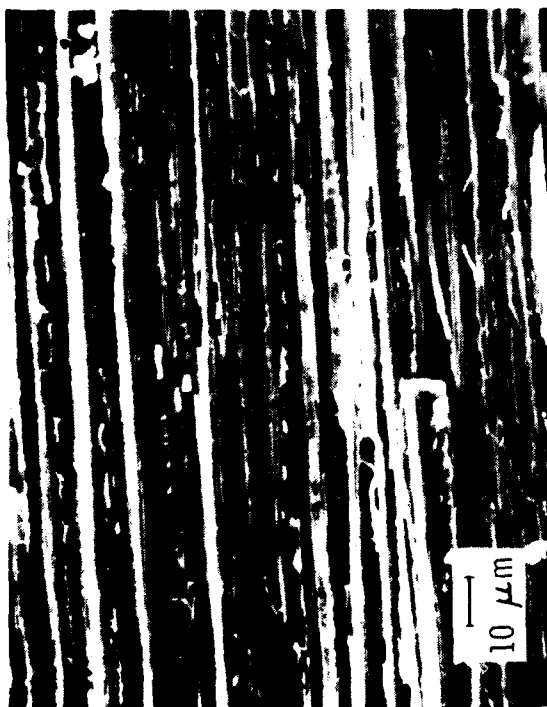
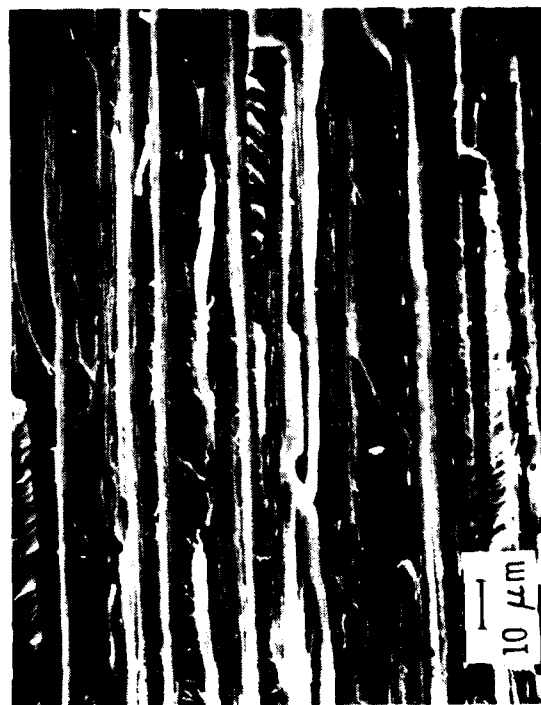
Figure 8. Beta = 90 deg, K_T Only. T300/1034c

Figure 8, $\beta = 90^\circ$, K_I only.

The 800X views show the matrix has failed in a smooth cleavage fashion. Very many long matrix wedges are visible. These result from the resin areas between fibers. (See Figure 7).

Note the clean fiber breaks. Some matrix lacerations, or hackles as they are sometimes called, are seen in the grooves of the missing fibers. These are likely due to local shearing along the side walls of the fiber as it was pulled away.

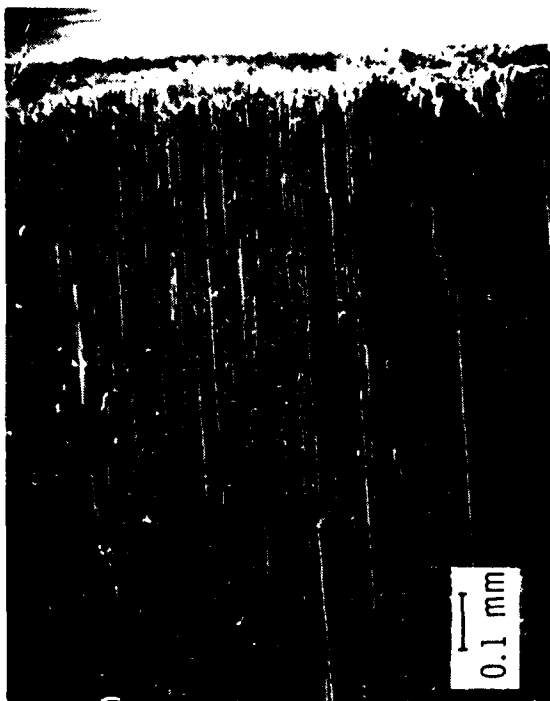
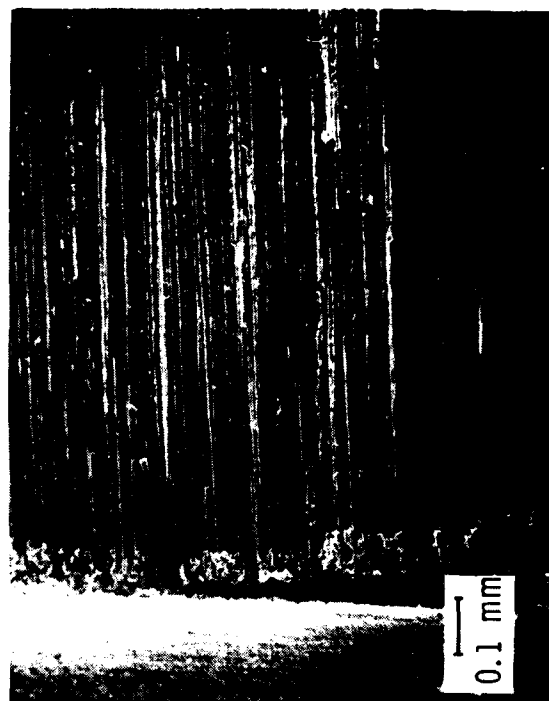
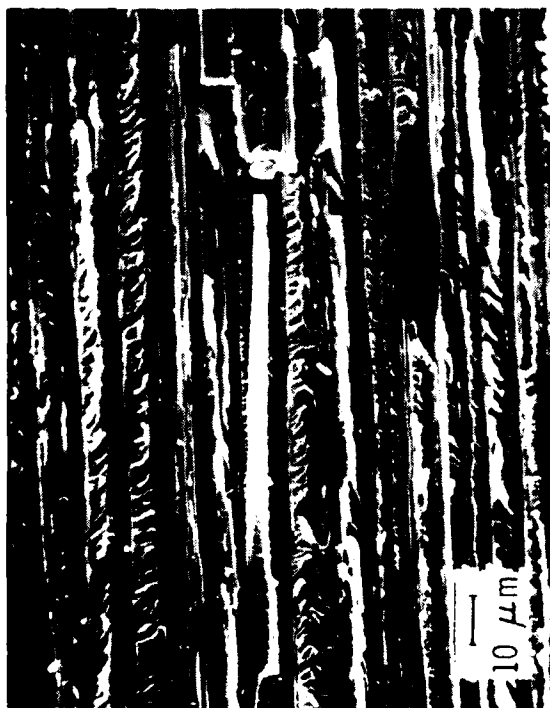
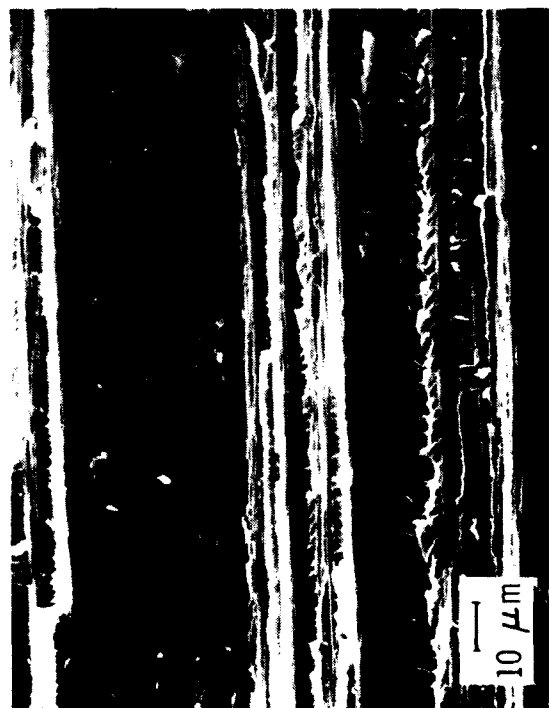
Figure 9. Beta = 45 deg, $K_I/K_{II} = 1.0$, 7300/1034c

Figure 9, $\beta = 45^\circ$, $K_I/K_{II} = 1.0$.

The 100X magnification shows a roughly equivalent number of fiber breaks in each direction on each surface. The first 800X photo (9c) shows a large number of fairly small hackles, evenly spaced and lying nearly flat. Matrix wedges are still visible. There were some bands with no hackles, as shown in Figure 9(d). Note the hackles form in the resin areas between fibers, as depicted in Figure 7. The fibers bordering the hackles may still be in place, 9(d), or missing, 9(c).

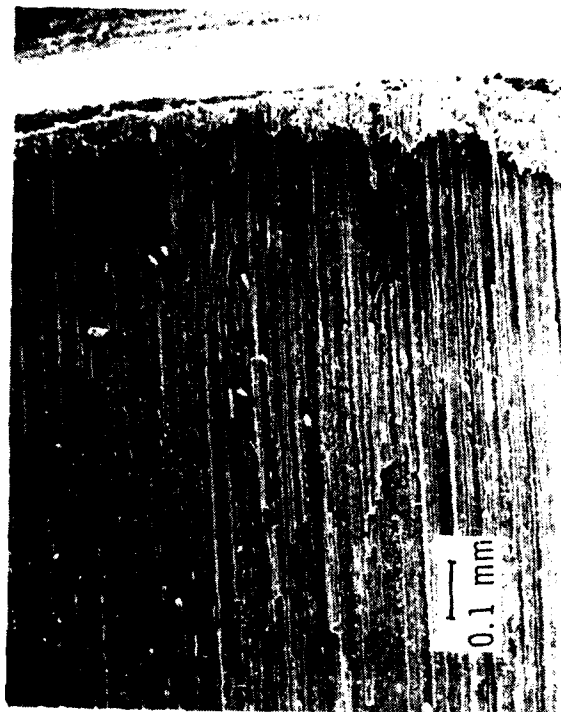
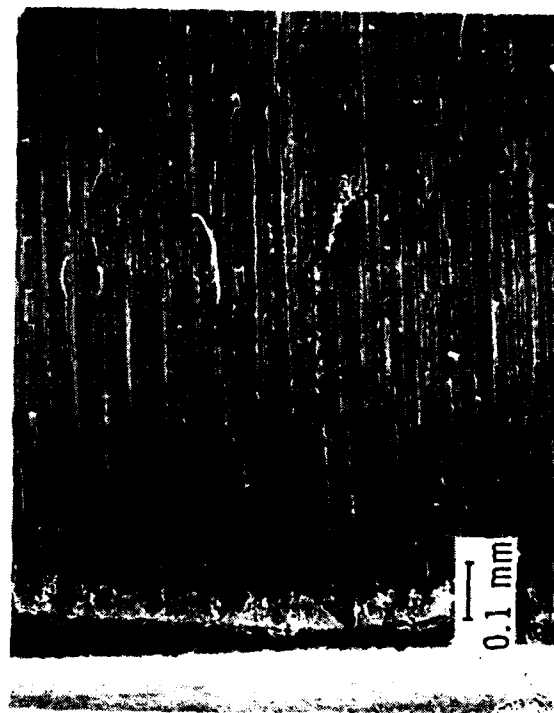
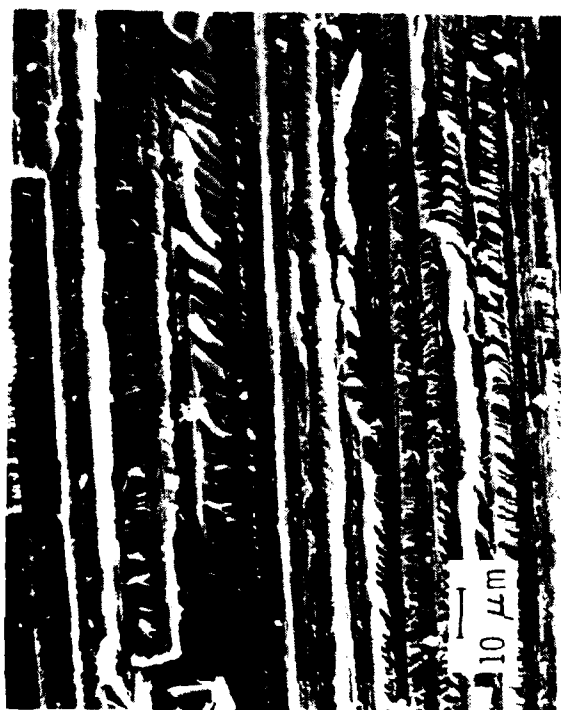
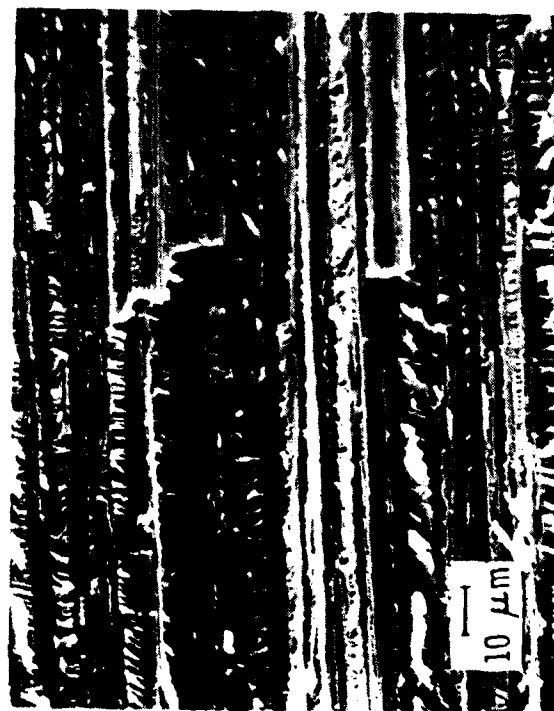
Figure 10. $\beta_{\text{eff}} = 70^\circ$, $F_{\text{I}}/F_{\text{II}} = 0.58$, T300/1034c

Figure 10, $\beta = 30^\circ$, $K_I/K_{II} = 0.58$.

The 100X photos show there are still many broken fibers in both directions, although there are more pointing to the left. Figure 6 shows that fibers on both surfaces experience a force to the left due to the global shear force. If the fibers break more easily in tension than compression, one would indeed expect more broken fibers pointing left. The 800X views show the hackles have become more raised than in the 45° specimen, as expected in the discussion earlier. Also visible are large hackles, formed in an area with more space between fibers.

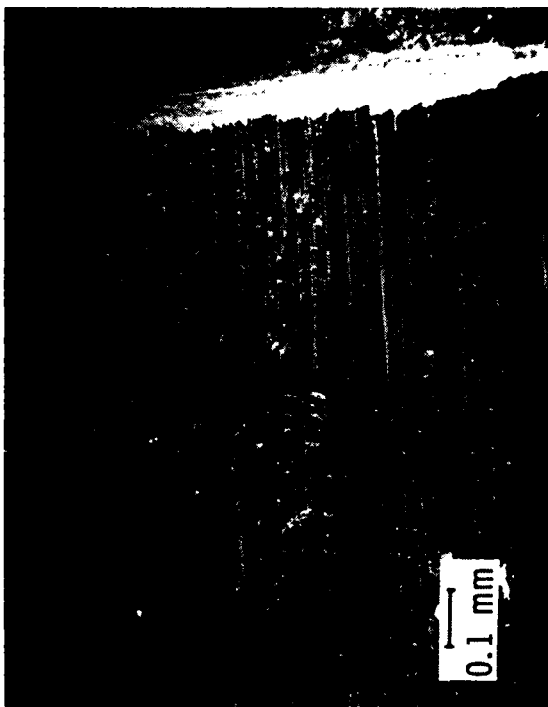
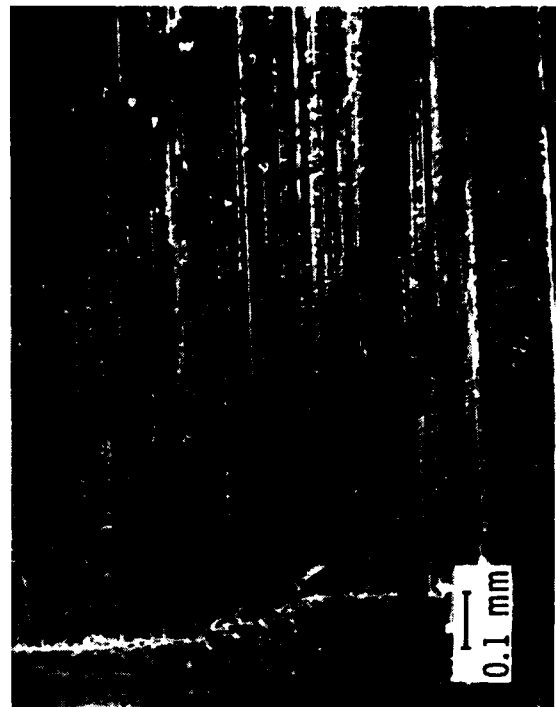
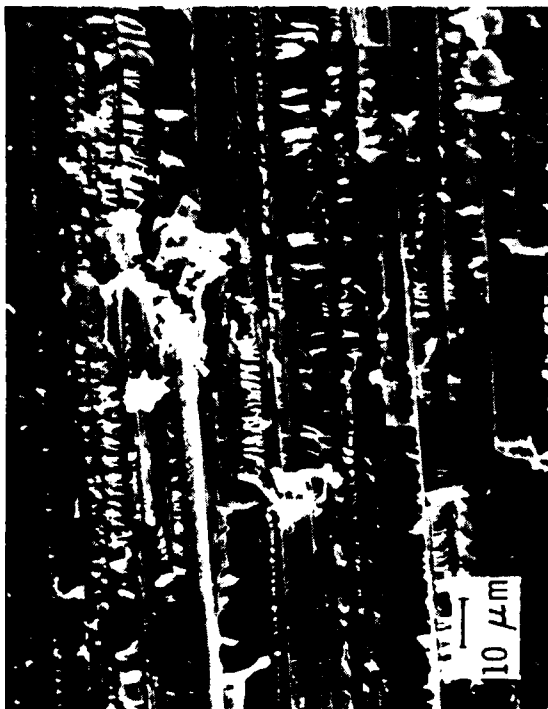
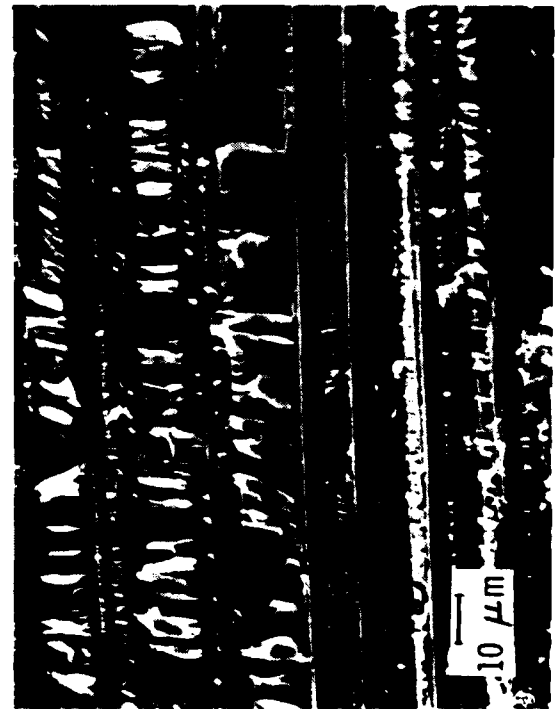
Figure 11. $\beta = 15^\circ$, $R_I/K_{11} = 0.27$, 1300/1035.

Figure 11, $\beta = 15^\circ$, $K_I/K_{II} = 0.27$.

By now, nearly all of the fiber breaks point left, as shown in the 100X photos. The 800X shows the hackles are nearly vertical - more than expected from the stress analysis. Their spacing has become very irregular. The fiber breaks clearly show the effects of shear direction. Broken fibers pointing to the left have failed in tension. Broken fibers

pointing to the right show a compression mushrooming type of failure. An increase in resin debris, as reported by Hahn and Johannesson [11] is apparent.

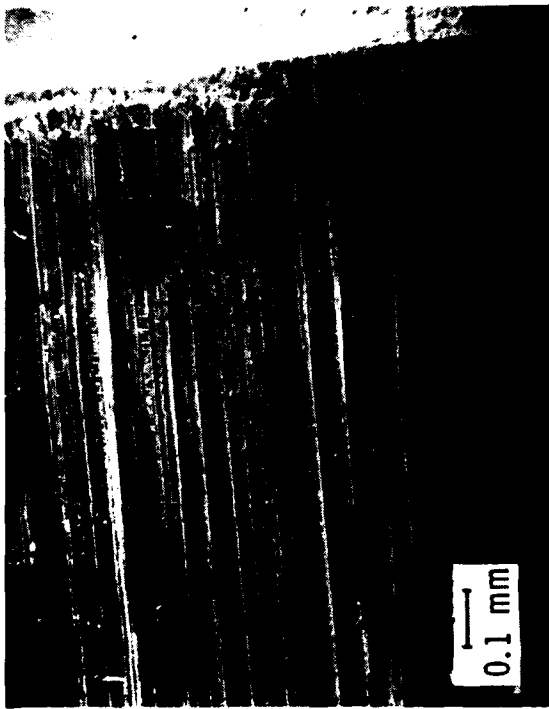
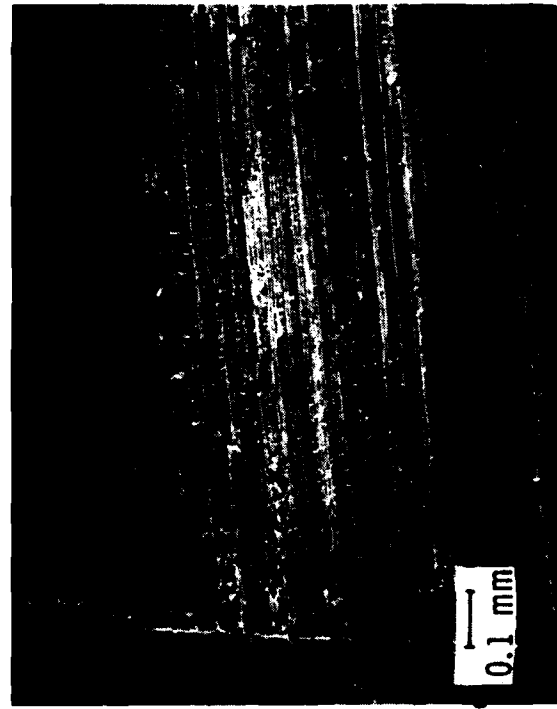
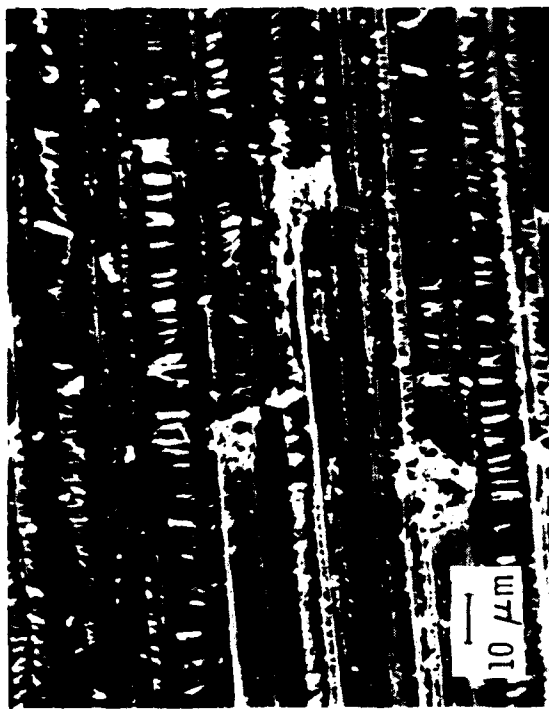
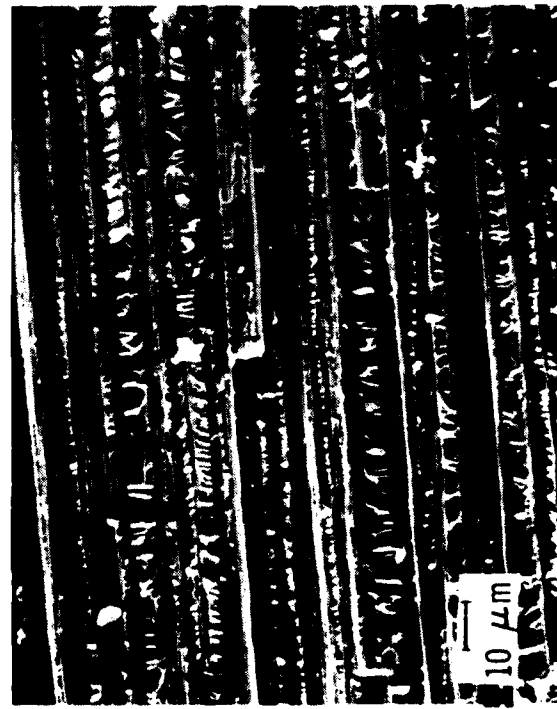
Figure 12. Beta = 10 deg, $K_I/K_{II} = 0.18$. T300/1034c

Figure 12, $\beta = 10^\circ$, $K_I/K_{II} = 0.18$.

Fibers broken in tension, 12(d), and compression, 12(c), clearly show shear direction. The hackle spacing is more irregular.

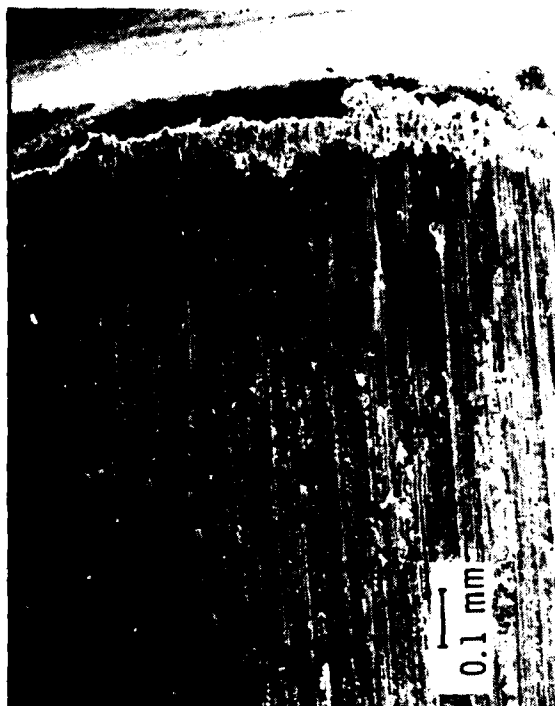
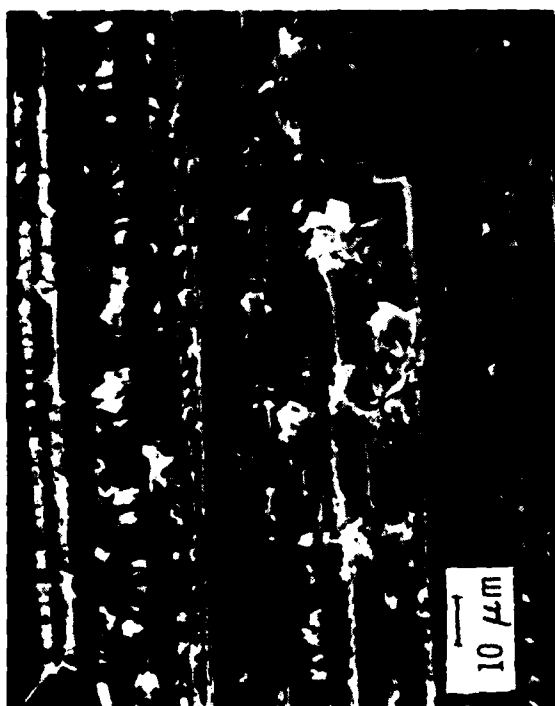
Figure 13. Rail Shear, K_{II} Only. T300/1034c

Figure 13, Rail Shear, K_{II} only.

The fiber breaks continue their failure pattern. Some have even segmented and are wedged with resin debris, 13(d). The matrix hackles have become very block-like (they are referred to by Purslow [7] as cusps), and exist only in the deep crevices between fibers. Their spacing is very intermittent. Exposed fiber surfaces are stripped clean.

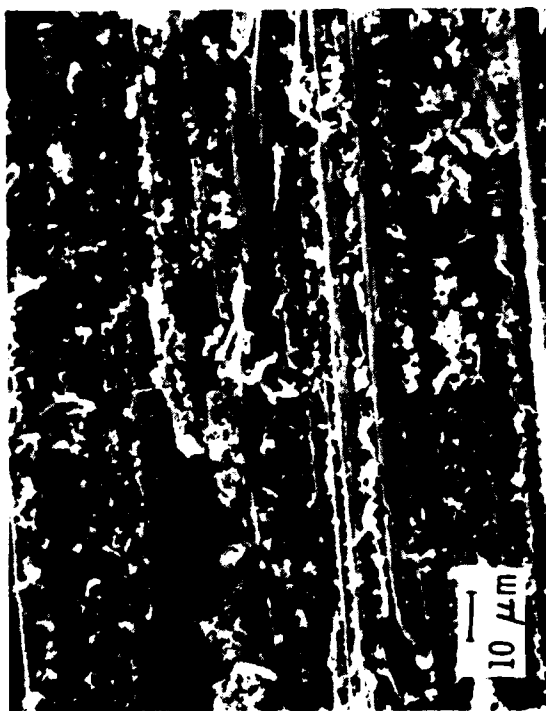
Figure 14. Beta = 15 deg Compression, $K_I/K_{II} = -0.27$ T300/1034c

Figure 14, $\beta = 15^\circ$ compression, $K_I/K_{II} = -0.27$.

In these photos, the shear direction is opposite to that shown in Figure 6. Note the large amount of resin debris remaining on the surface. Some areas, 14(c), show segmented fibers. The surface has a general ground down appearance, as expected due to friction between the upper and lower surfaces during fracture.

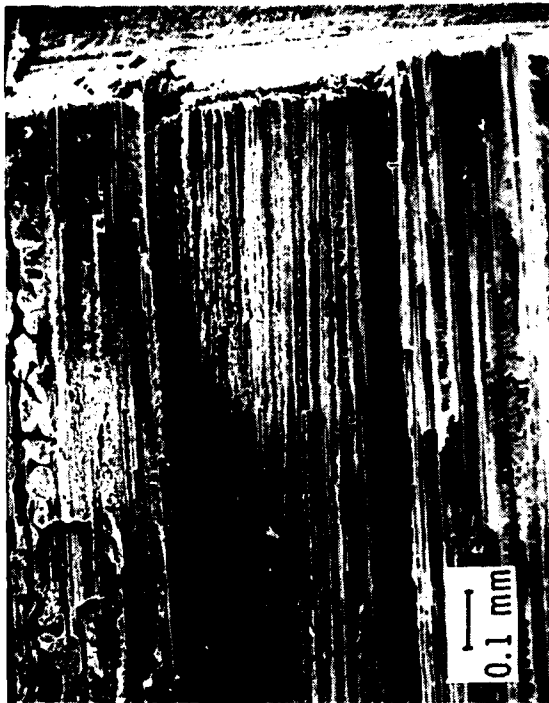
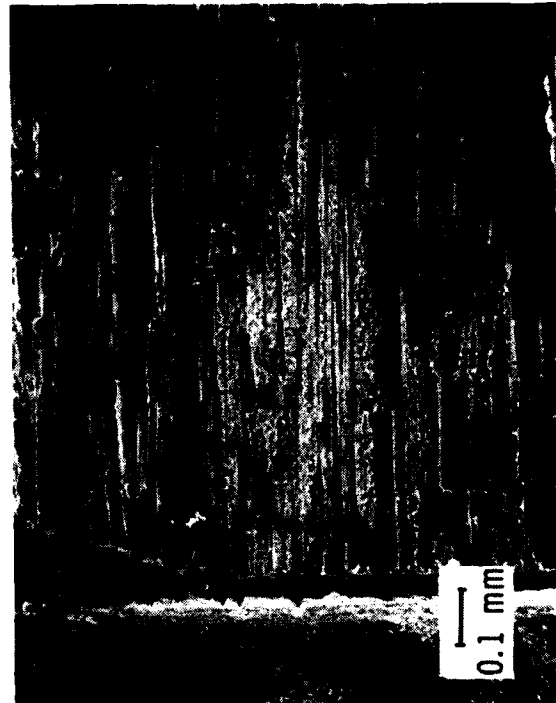
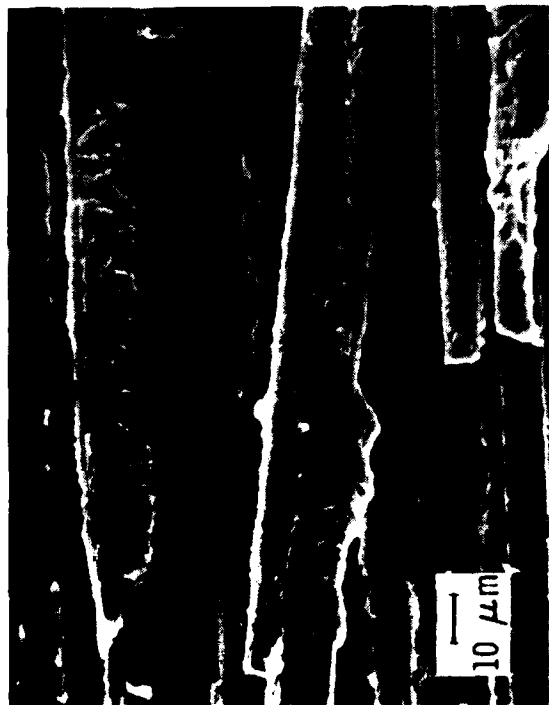
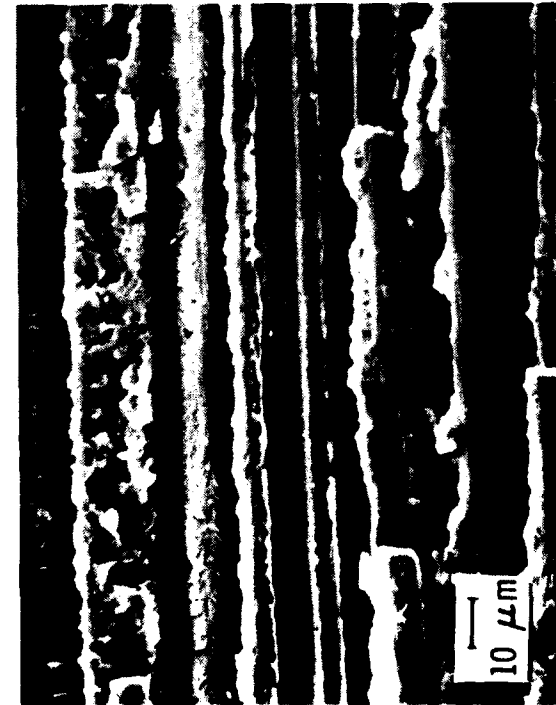
Figure 15. Beta = 90 deg. K_T Only. APC-1

Figure 15, $\beta = 90^\circ$, K_I only.

Even at 100X it is obvious that much more energy went into the fracture than into the equivalent epoxy specimen. The surface is very uneven, and some groups of fibers have been pulled up. Higher magnification shows large amounts of resin adhered to the fibers.

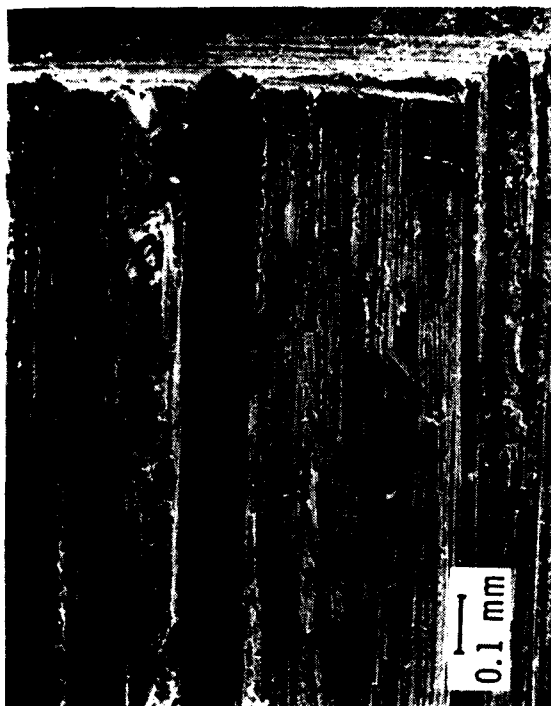
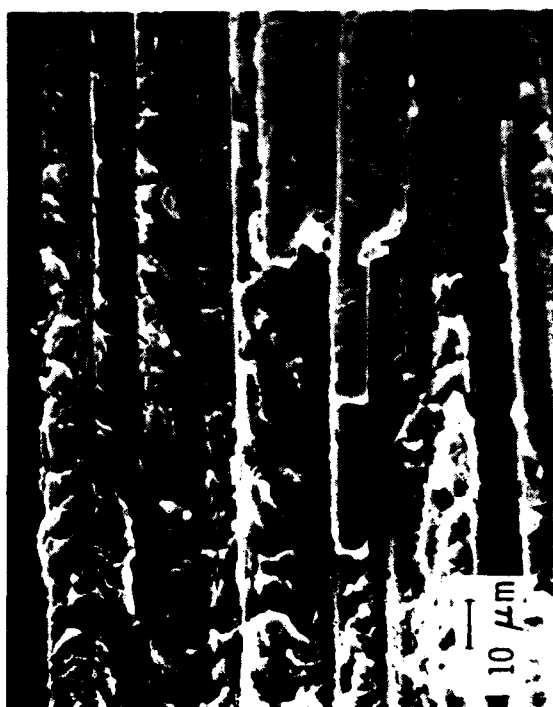
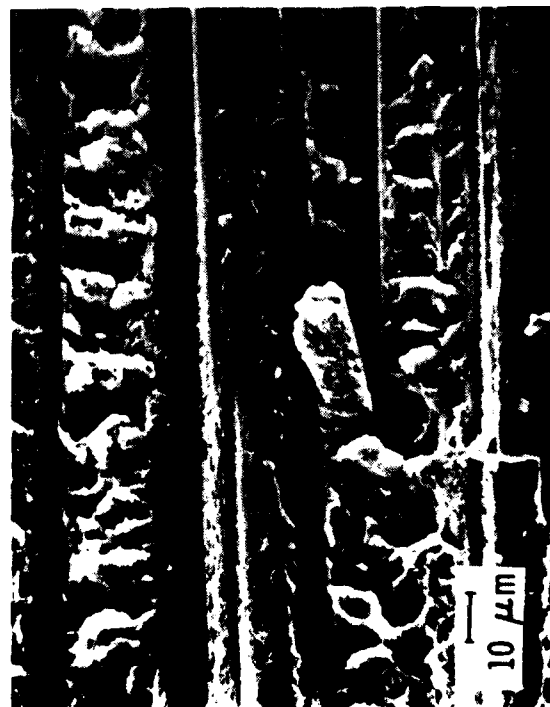
Figure 16. Beta = 45 deg, $K_I/K_{II} = 1.0$. APC-1

Figure 16, $\beta = 45^\circ$, $K_I/K_{II} = 1.0$.

The 100X photos show that most broken fibers point to the left on both surfaces. The 800X shots show rough, thick hackles. Figure 16(c) shows tensile, and 16(d), compressive evidence to show shear direction in the graphite/PEEK. This direction agrees with the hackle orientation.

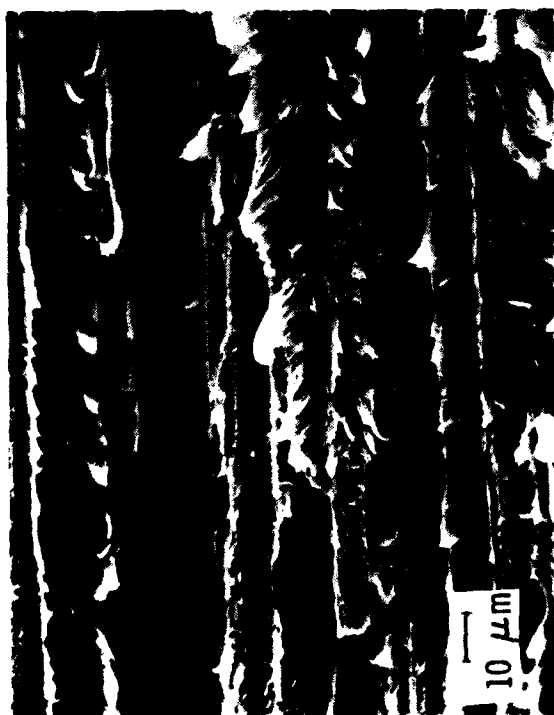
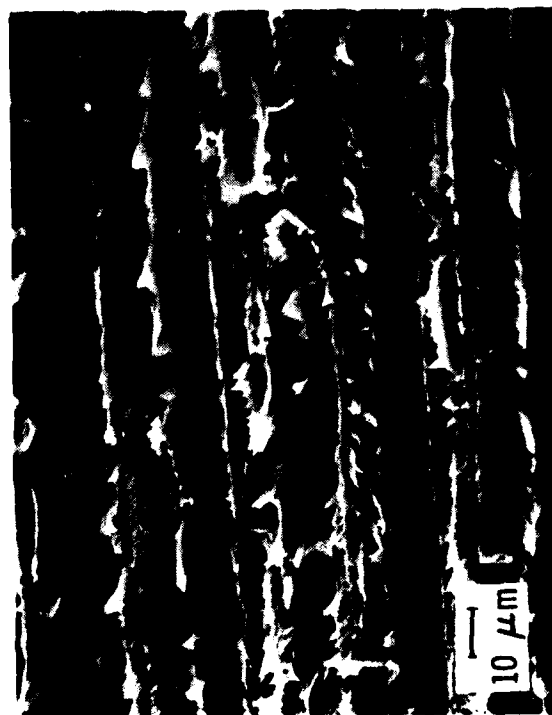
Figure 17. $\beta = 15^\circ$, $K_I/K_{II} = 0.27$. APC-1

Figure 17, $\beta = 15^\circ$, $K_I/K_{II} = 0.27$.

A series of pointed spike formations are present in the region of the crack tip. Note they point in the direction of the applied shear stress. These spikes appear as though formed by crazing [12]: As the opposing fracture surfaces displaced under opening and shear forces, the spikes necked down in a ductile manner until they broke off at the mid-section.

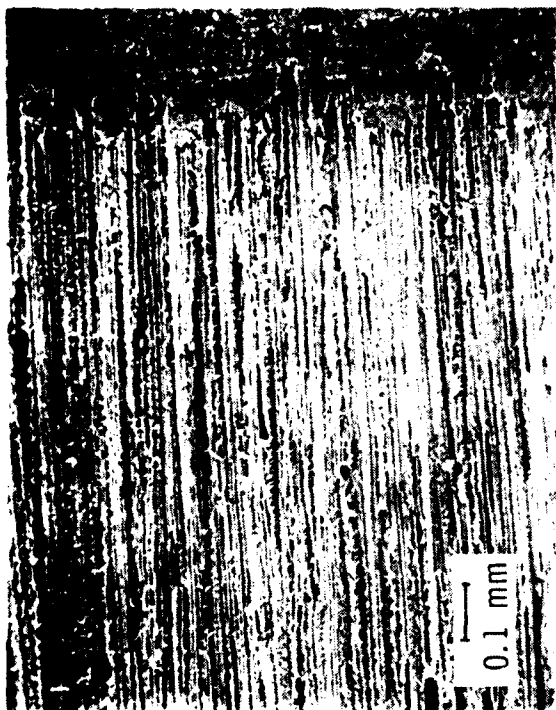
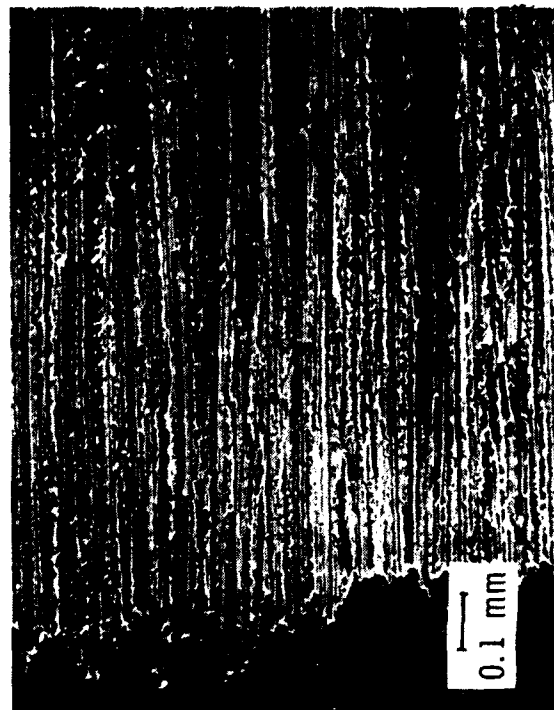
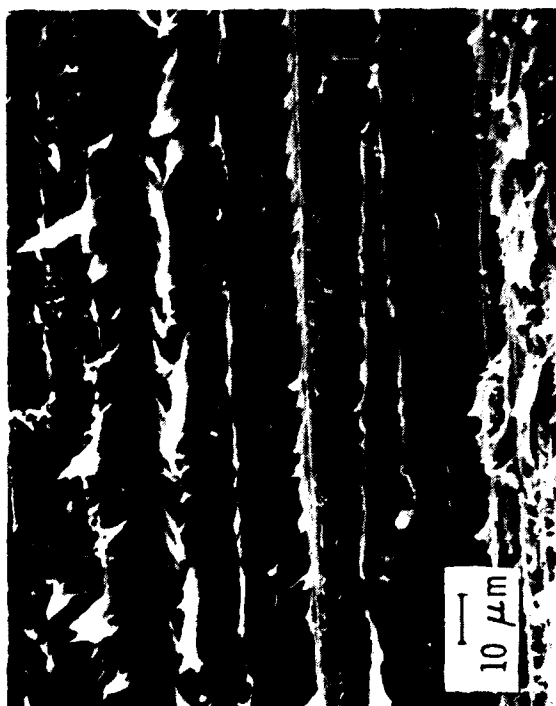
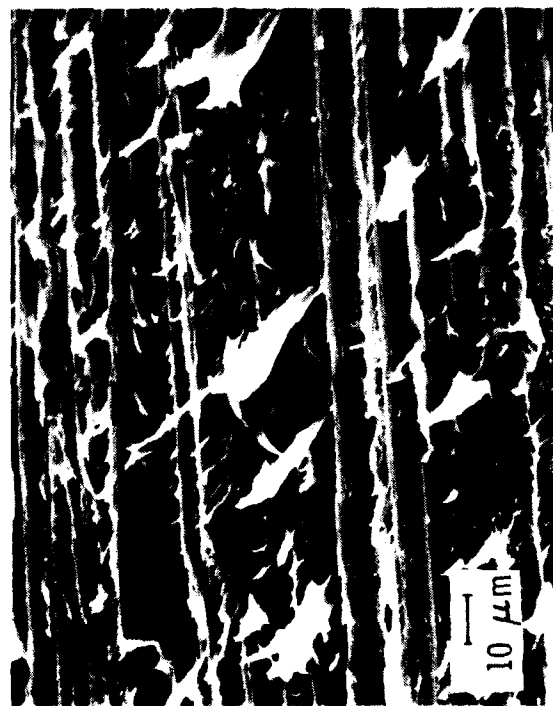
Figure 18. $\text{Beta} = 10 \text{ deg}$, $K_{11}/K_{33} = 0.18$. APC-1

Figure 18, $\beta = 10^\circ$, $K_I/K_{II} = 0.18$.

The spike formations are still prevalent. Figure 18(c) shows tensile and compressive fiber failures. Figure 18(d) shows a rare feature found

on the surface: sheaths from around the fibers pulled-up almost cobra-like.

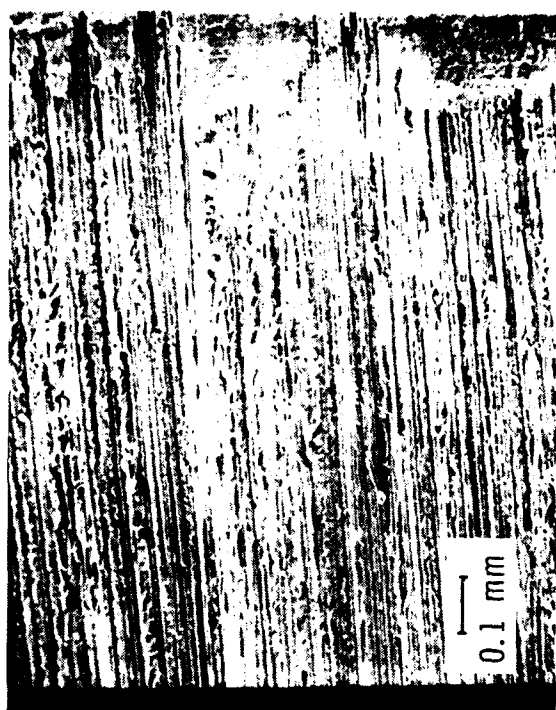
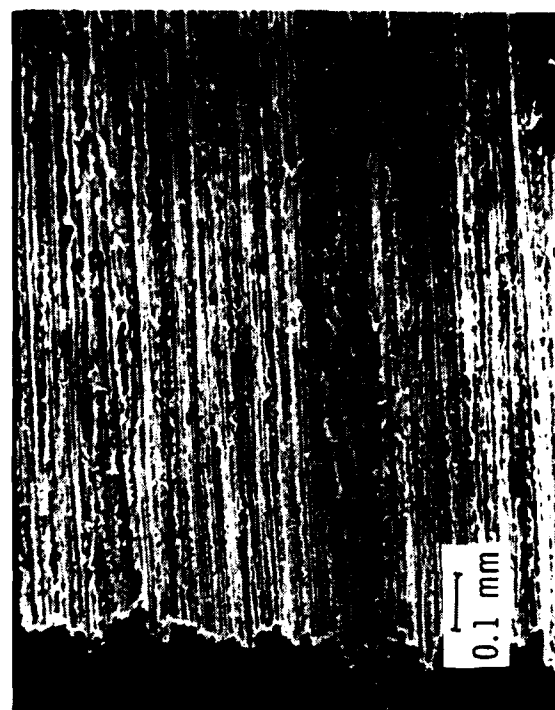
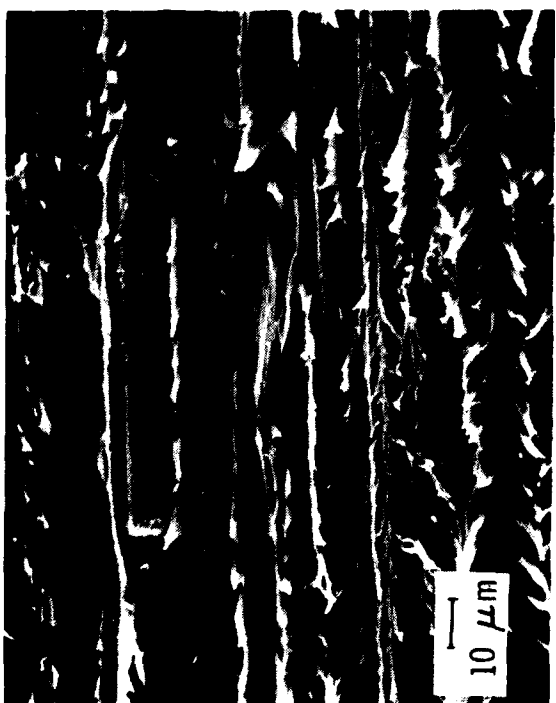
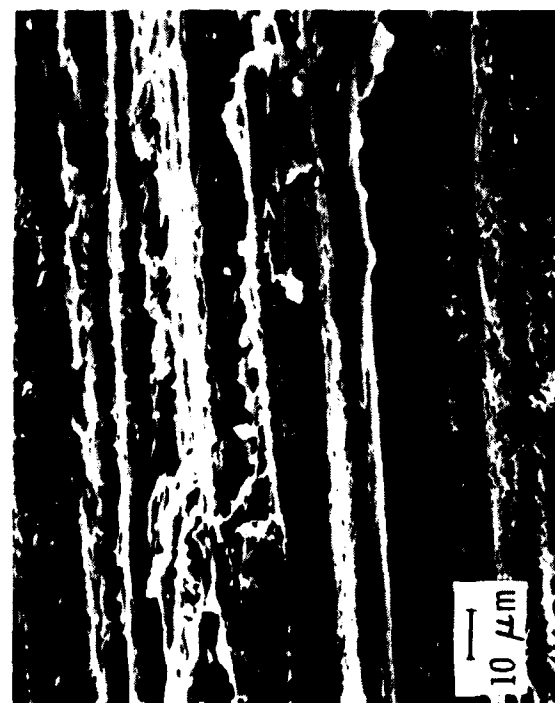
Figure 19. Rail Shear, K_{II} Only. APC-1

Figure 19, Rail Shear, K_{II} only.

The spikes in Figure 19(c) are well developed and leaning strongly in the shear direction. Tensile and compressive fiber breaks can be seen in this photograph. There are also smooth bands on the fracture surface, shown in Figure 19(d) at 800X. Compressive fiber failures can be seen in this photo.

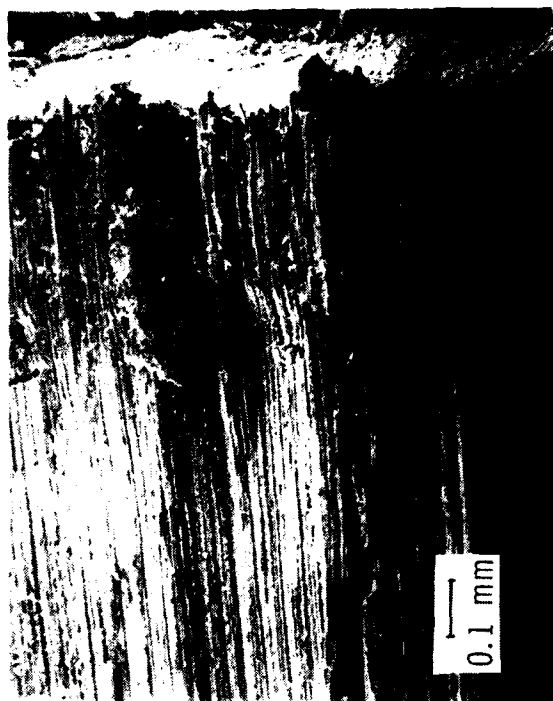
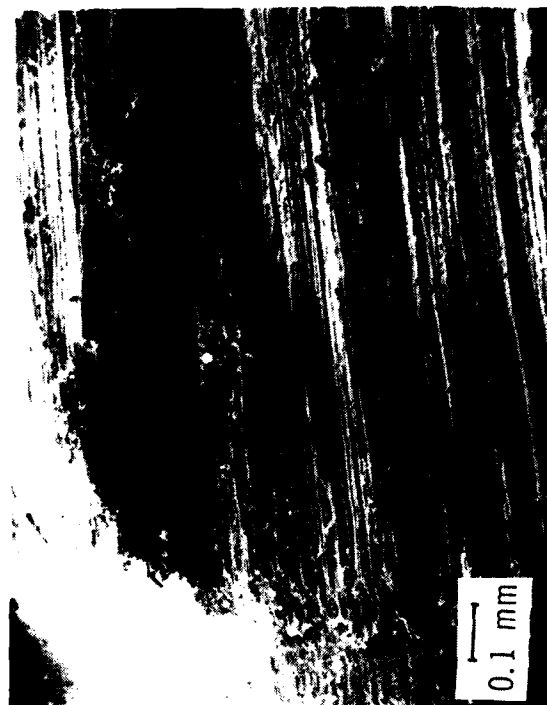
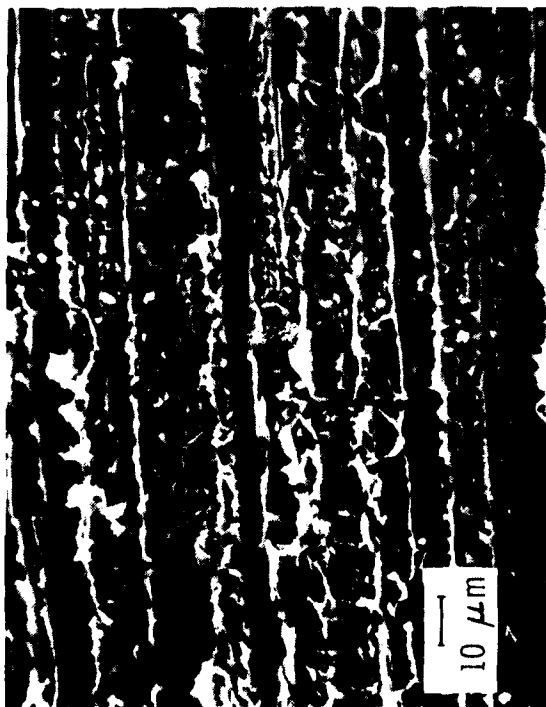
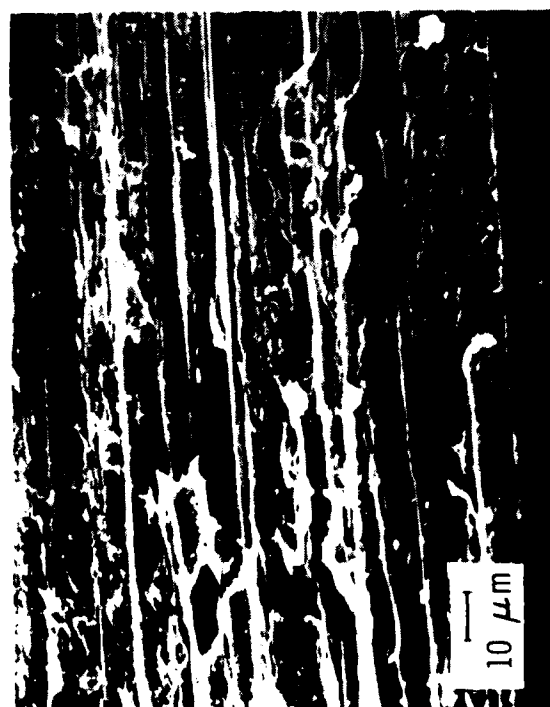
Figure 20. Beta = 15 deg Compression, $K_I/K_{II} = -0.27$, APC-1

Figure 20, $\beta = 15^\circ$ compression, $K_I/K_{II} = -0.27$.

The surface at 100X shows the specimen buckling that occurred in compression. The surface had several zones. One type, as shown in Figure 20(c), was mottled and had much debris. The second type was smoother and darker, 20(d).
